Intel[®] Pentium[®] II Xeon[™] Processor Specification Update

Release Date: November 2001

Order Number: 243776-031

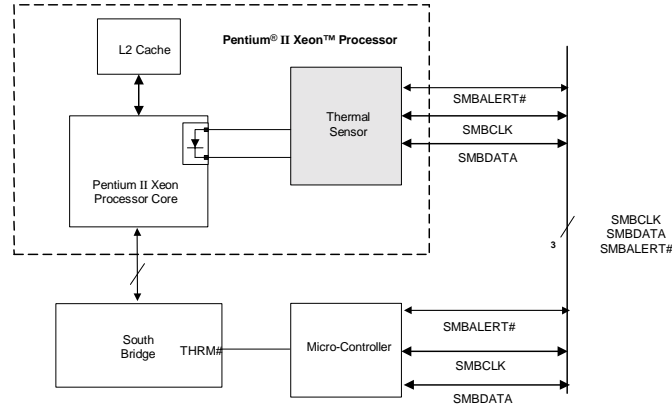
Figure 1. An Example of Microcontroller Driven Thermal Management

Problem: The Pentium II Xeon processor has a thermal sensor that monitors the processor core's temperature. The thermal sensor asserts SMBALERT# if the processor temperature exceeds the temperature limits set in the Alarm Threshold Registers (T_{HIGH} , T_{LOW}). It also sets the corresponding Status Register bits to identify the cause of the interrupt. Figure 1 gives one example of the how the SMBALERT# signal could be used in a system.

Under the conditions described below, the thermal sensor incorrectly generates the SMBALERT# interrupt. *All* of the following conditions must be met to trigger a false interrupt:
