# S10 / S10 MMI

### Repair Documentation

#### Level 2.5

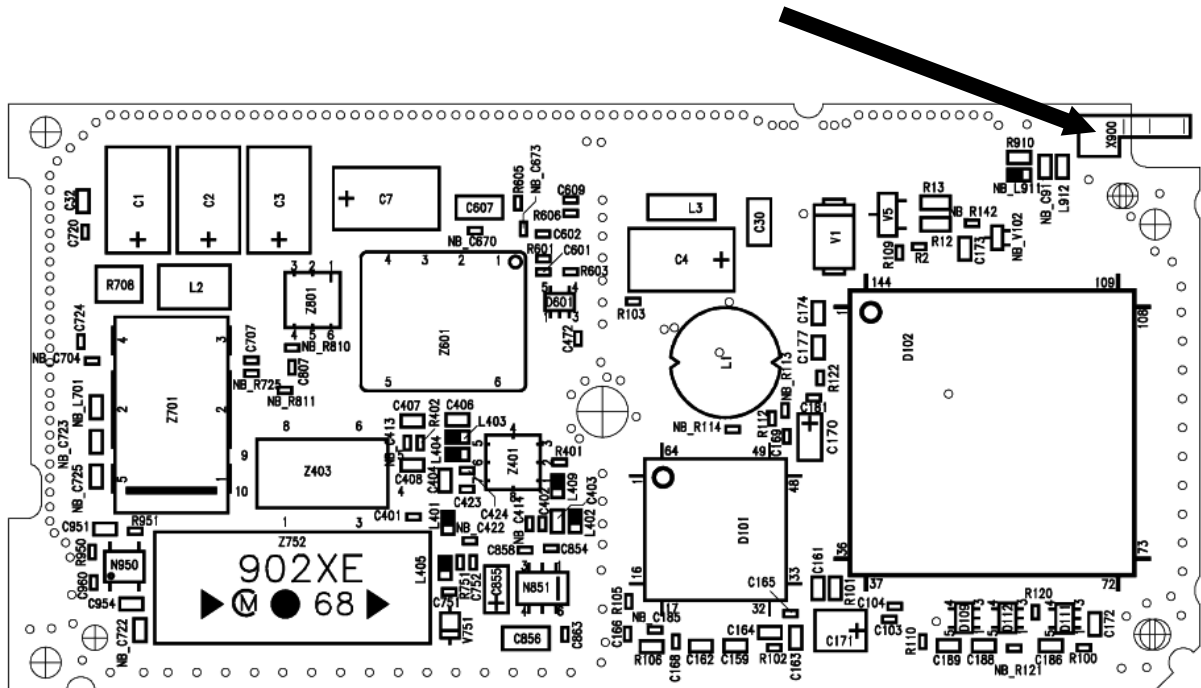
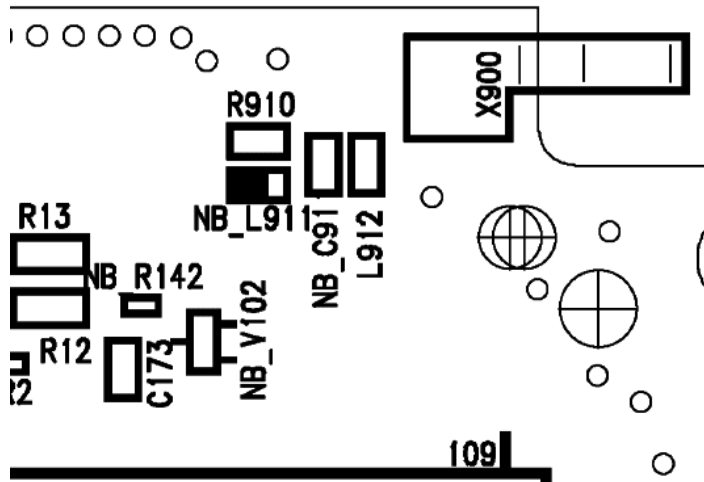
Figure 2: S10 / S10 active Antenna Spring (X900) Placement (Top View)

Customers experience a low Rx sensitivity of the hand-set, have problems registering to the network and making calls.

The GSM-Tester will show a low Tx-Power only on the *internal* antenna (aerial coupler measurement!).

Visually check the status of the antenna spring. Look for a bent contact or dry soldering joint.

Use soldering iron to remove defective spring.

Resolder new spring afterwards.

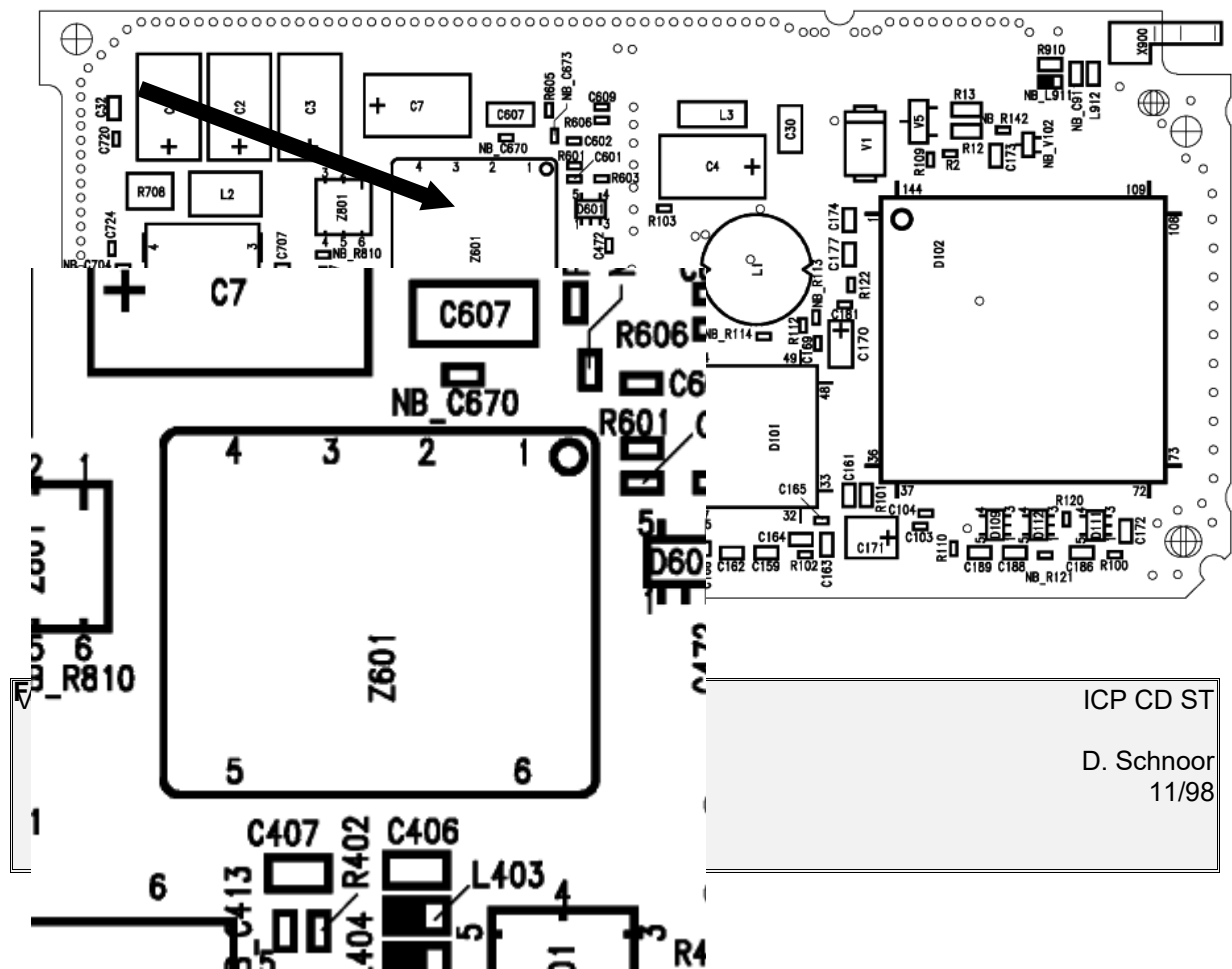
Figure 1: S10 Board TCXO Side

Frequency error in synchronized mode >90 Hz

If the frequency error is higher than 2kHz, the TCXO has to be replaced.

Use hot air blower to remove defective TCXO.

Resolder new TCXO afterwards.

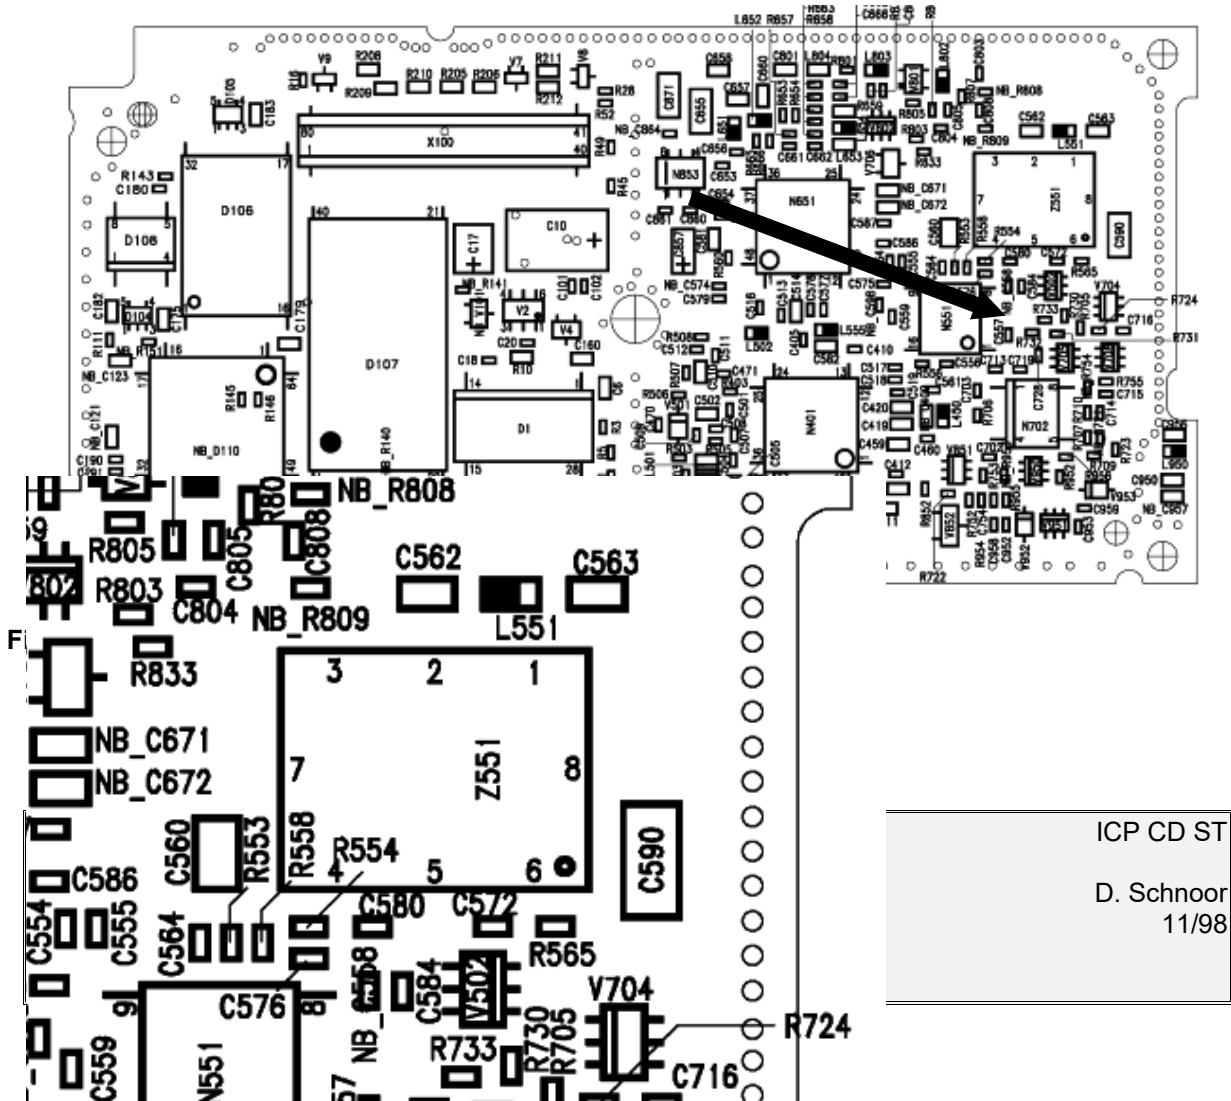
Figure 1: S10 Board VCO Side

Phase error in synchronized mode >5 deg rms  
or >20 deg or >-20 deg peak.  
No location update possible

Use hot air blower to remove defective VCO.  
Avoid excessive heat!  
Watch surrounding components!

Resolder new VCO afterwards.

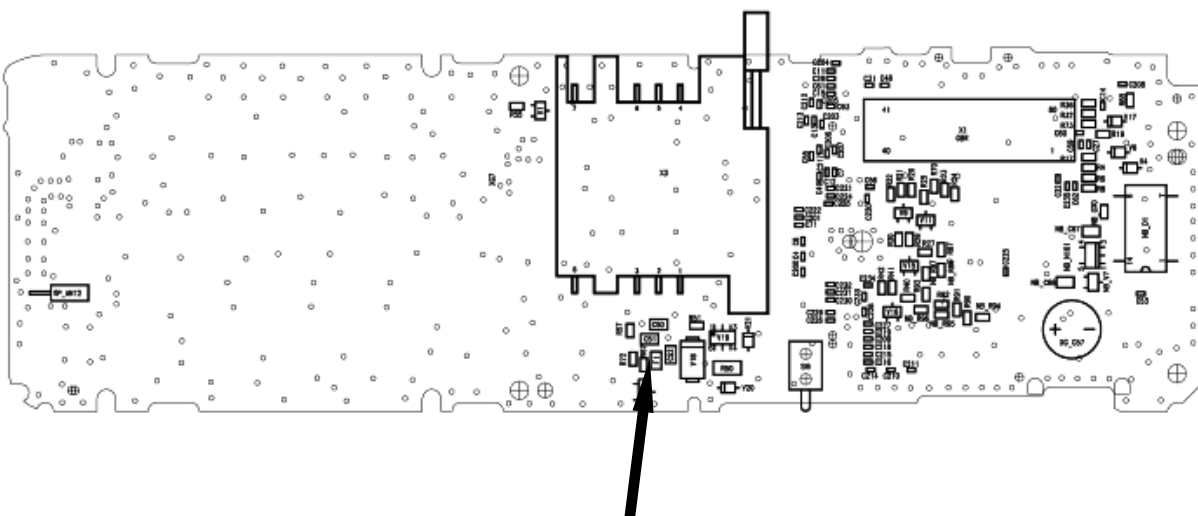
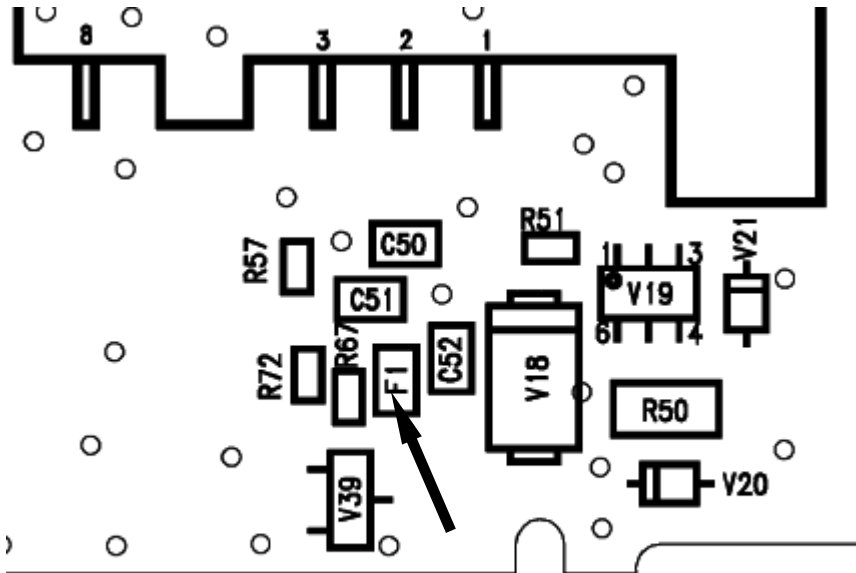
**Figure 1: S10 / S10 active MMI Board 1A Fuse Side**

Battery charging not possible

Check the status of the fuse by measuring its resistance with a multimeter. The fuse is defective if the resistance higher than 10 ohms

Use soldering iron to remove defective fuse.  
Avoid excessive heat!  
Watch surrounding components!

Resolder new fuse afterwards.

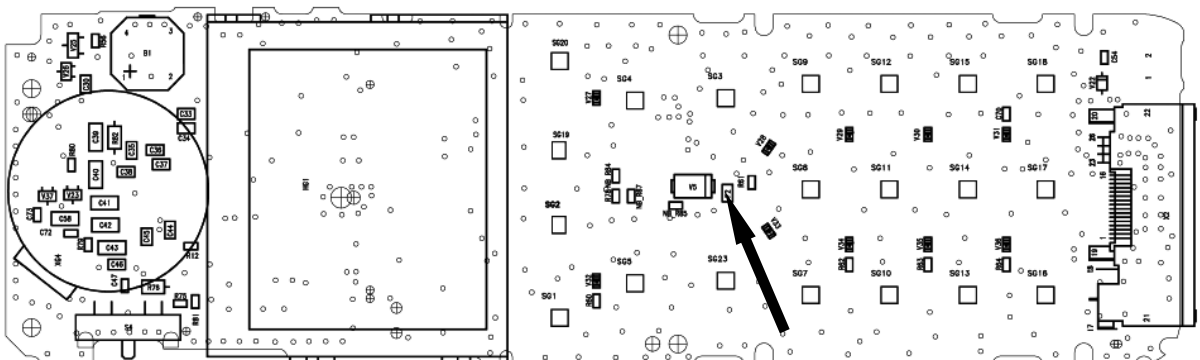
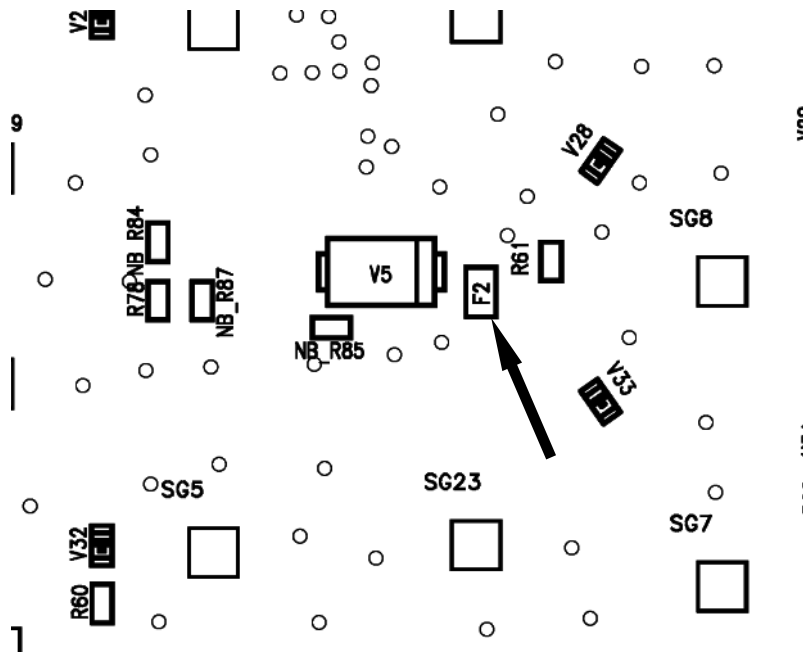
Figure 2: 0.25A Fuse (F2) Placement (Top View)

Supplying of external accessories through the handset's bottom connector is not possible

Check the status of the fuse by measuring its resistance with a multimeter. The fuse is defective if the resistance is higher than 10 ohms

Use soldering iron to remove defective fuse.  
Avoid excessive heat!  
Watch surrounding components!

Resolder new fuse afterwards.

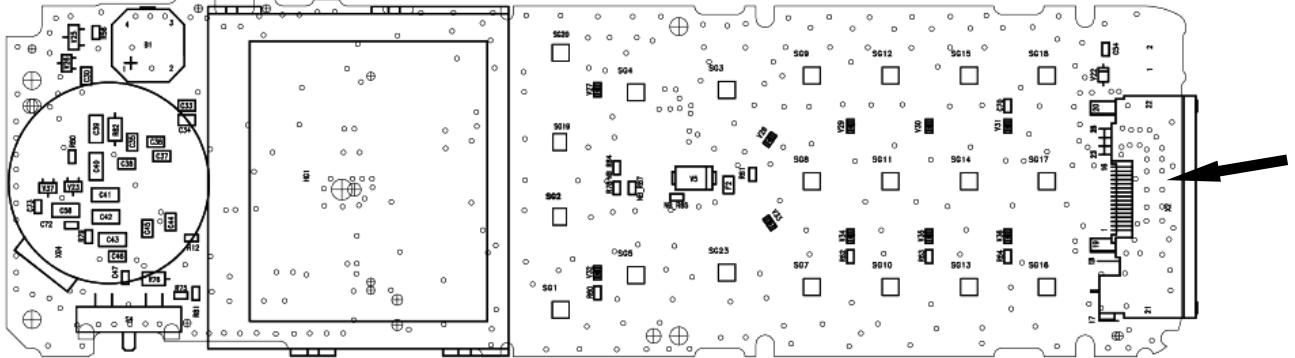
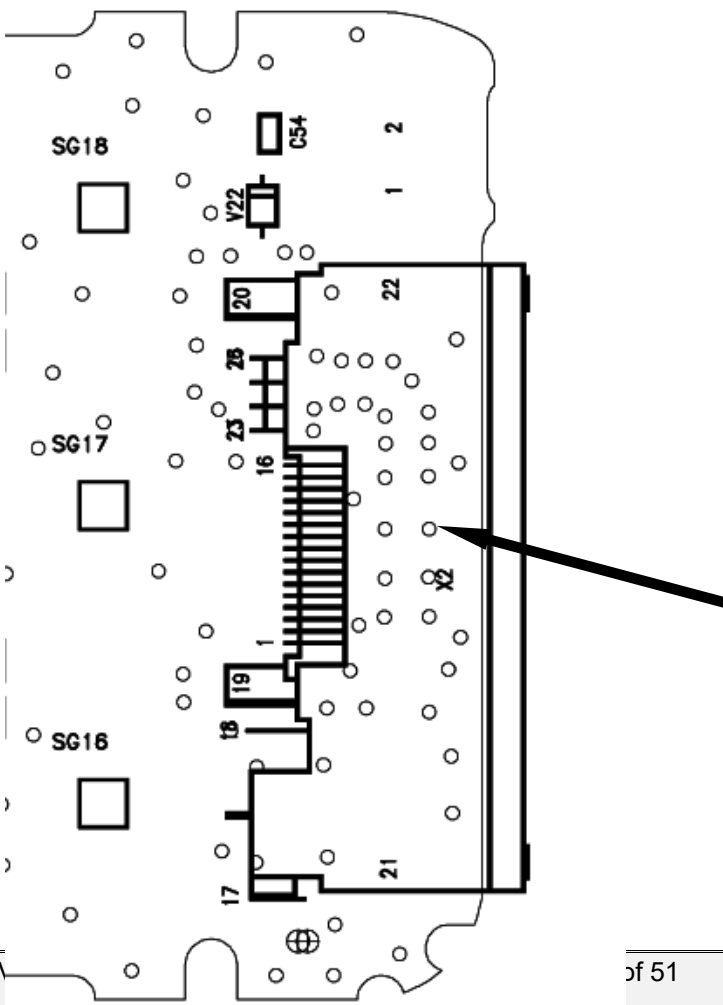
Figure 2: Bottom Connector Placement (Top View)

Charging or operation in a car kit not possible.

Output power problems on the external antenna only.

Visually check the bottom connector. Watch for dry joints.

Use hot air blower to remove defective connector.  
Avoid excessive heat!  
Watch surrounding components!

Resolder new connector afterwards.  
Make sure that you use just very little flux, otherwise the connector contacts can become dirty.

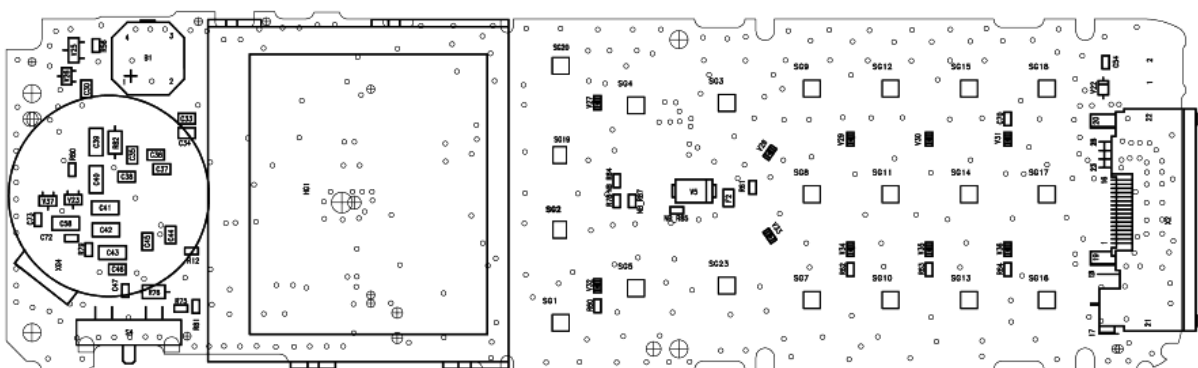
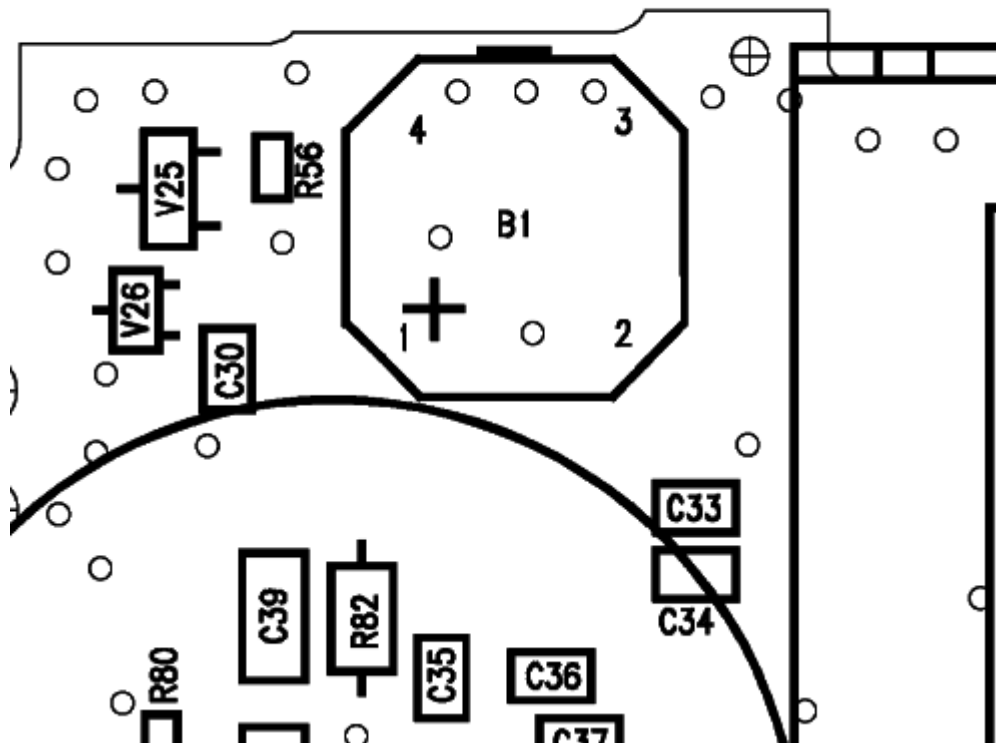
Figure 2: Ringer (B1) Placement (Top View)

No ringer tone audible or ringer tone distorted.

Use hot air blower remove defective ringer.  
Avoid excessive heat!  
Watch surrounding components, especially the display window!  
To protect the display, you can also desolder the ringer with solder wick.

Resolder new ringer afterwards.  
Watch placement of ringer!

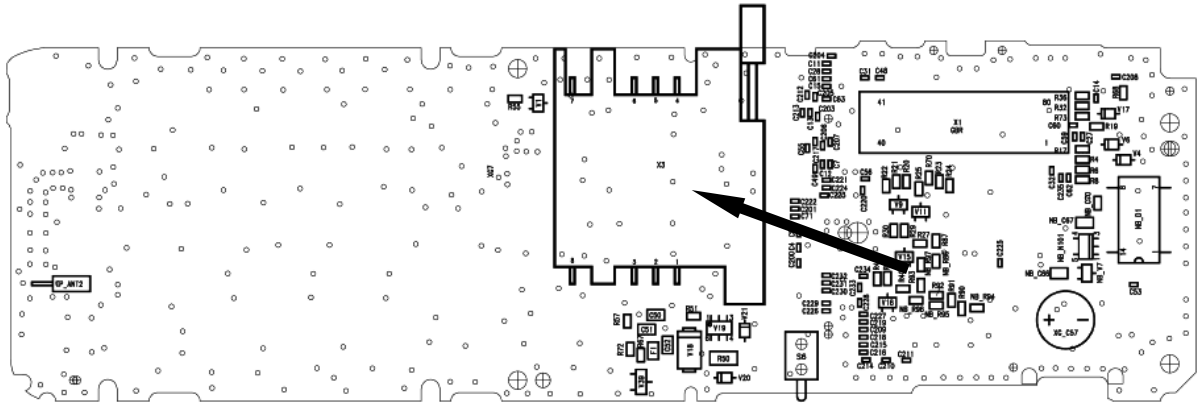
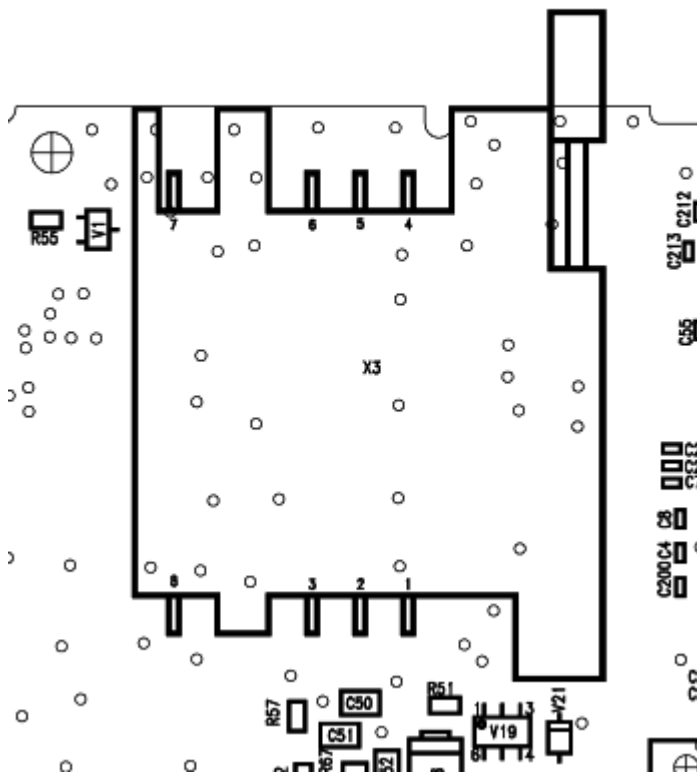
Figure 2: Cardreader Placement (Top View)

Sim card is not accepted or properly read by the handset.  
Sim card ejection mechanism may be damaged.

Check cardreader functionality with sim card.  
Attention: Watch for dry joints (especially pin 7!) or mechanical damage.

Resolder dry joints.

If the cardreader is mechanically damaged use solder wick to remove defective component.

Resolder new cardreader afterwards.

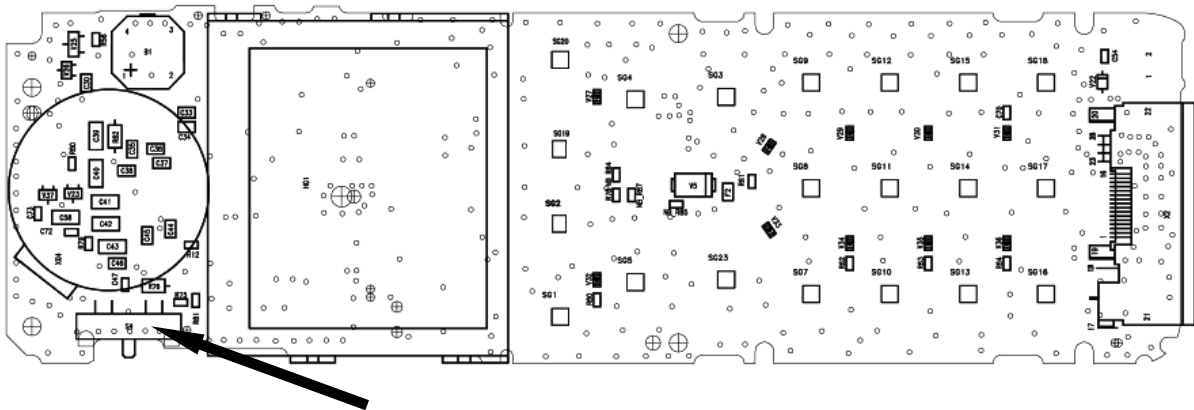
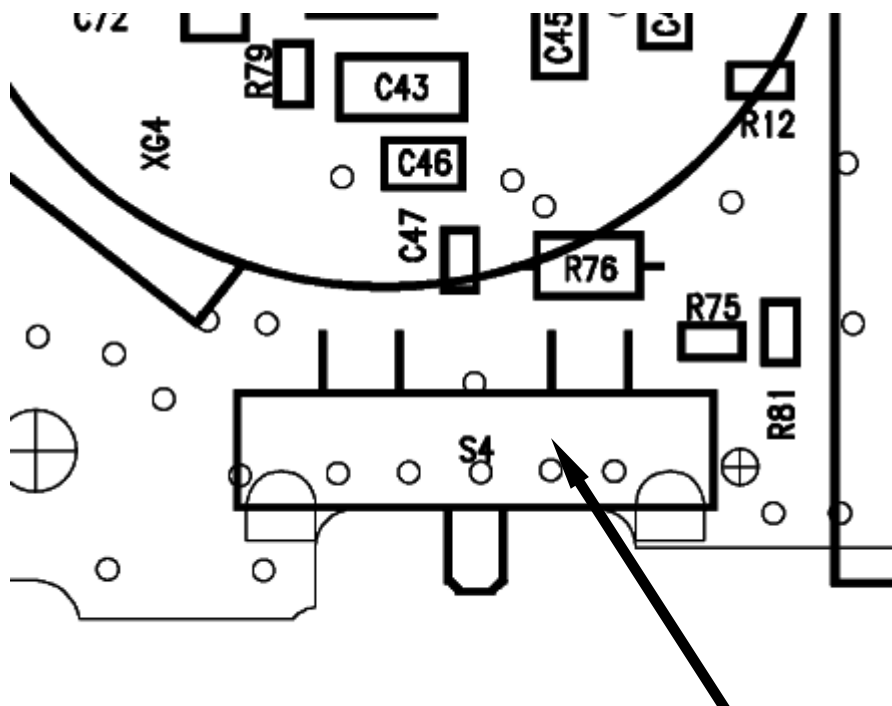
Figure 2: Volumeslider Placement (Top View)

The volume slider does not work properly.

Check volumeslider functionality either manually or with the testing program.  
Watch for dry joints or mechanical damage.

Use solder wick to remove defective slider.  
Avoid excessive heat!  
Watch surrounding components!!

Resolder new volumeslider afterwards.

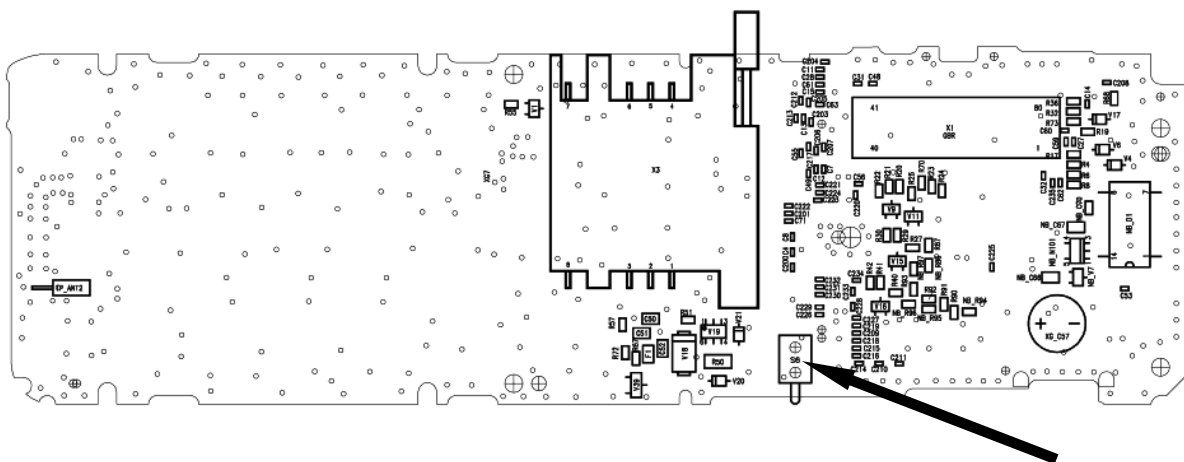
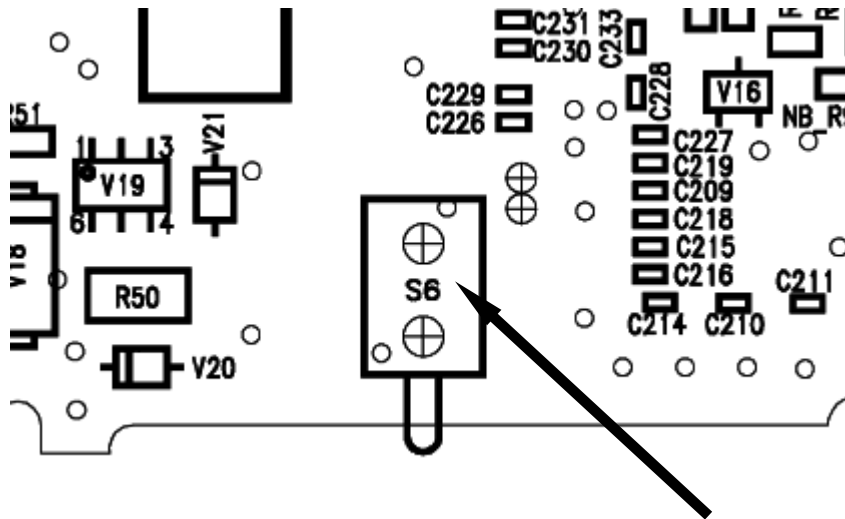
**Figure 2: Memoswitch (S6) Placement (Top View)**

The memoswitch does not work properly.

Check memoswitch functionality either manually or with the testing program.  
Watch for dry joints or mechanical damage.

Use solder wick or hot air to remove defective switch.  
Avoid excessive heat!  
Watch surrounding components!!

Resolder new memoswitch afterwards.

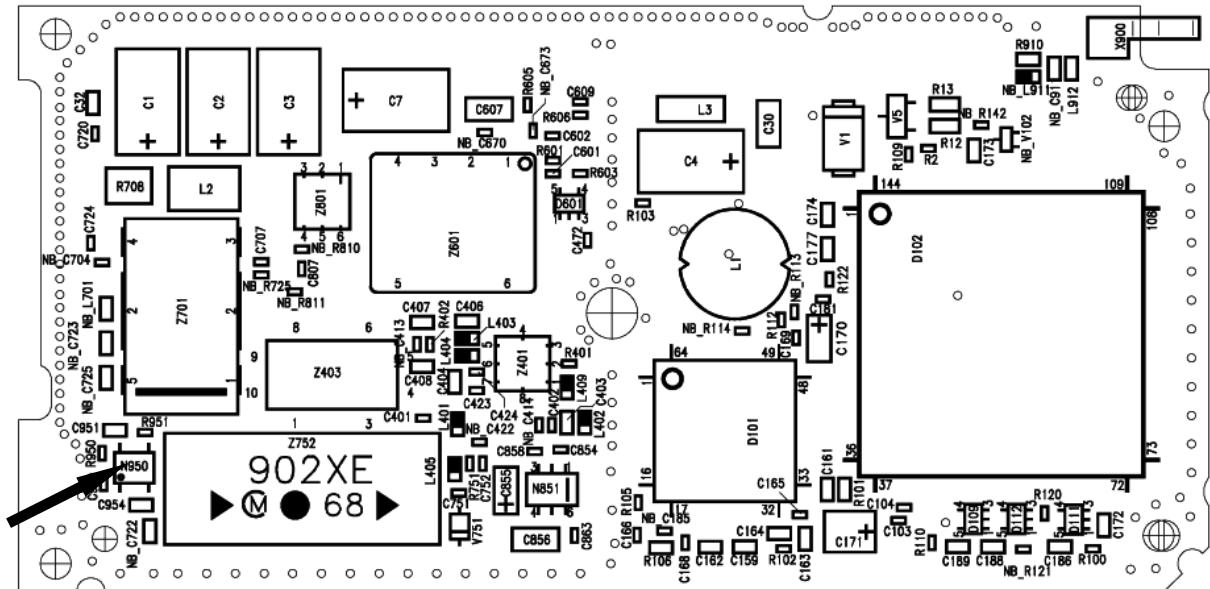
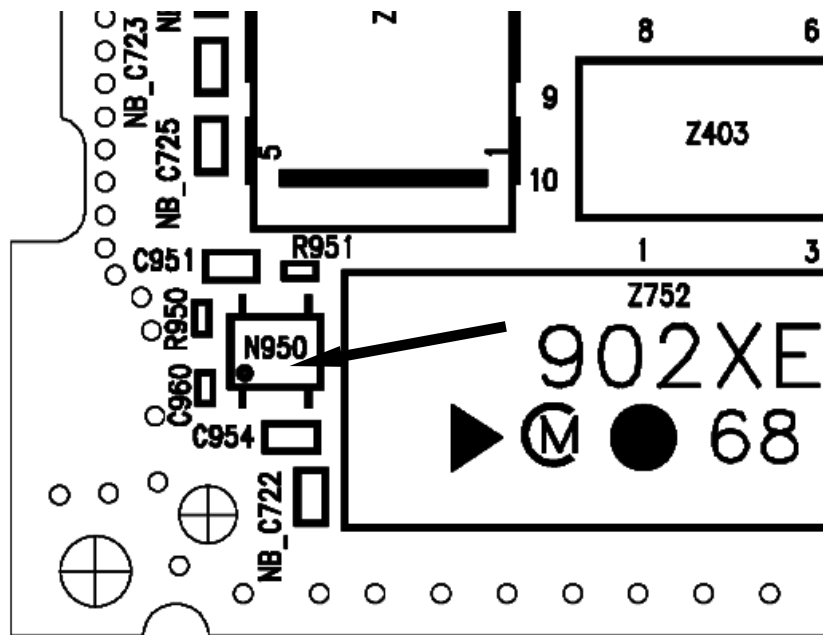
Figure 2: Antennaswitch (N950) Placement (Top View)

Handset fails with low Tx power on both or either antenna.  
No location update possible.

Pin 5 against ground must be around 50 kOhms.  
Pin 1 against ground must be around 1 kOhm.

If any of these resistances are significantly lower (for example pin 5 around 17 Ohms) the antennaswitch is defective and has to be replaced.

Use solder wick or hot air to remove defective switch.  
Avoid excessive heat!  
Watch surrounding components!!

Resolder new antennaswitch afterwards.

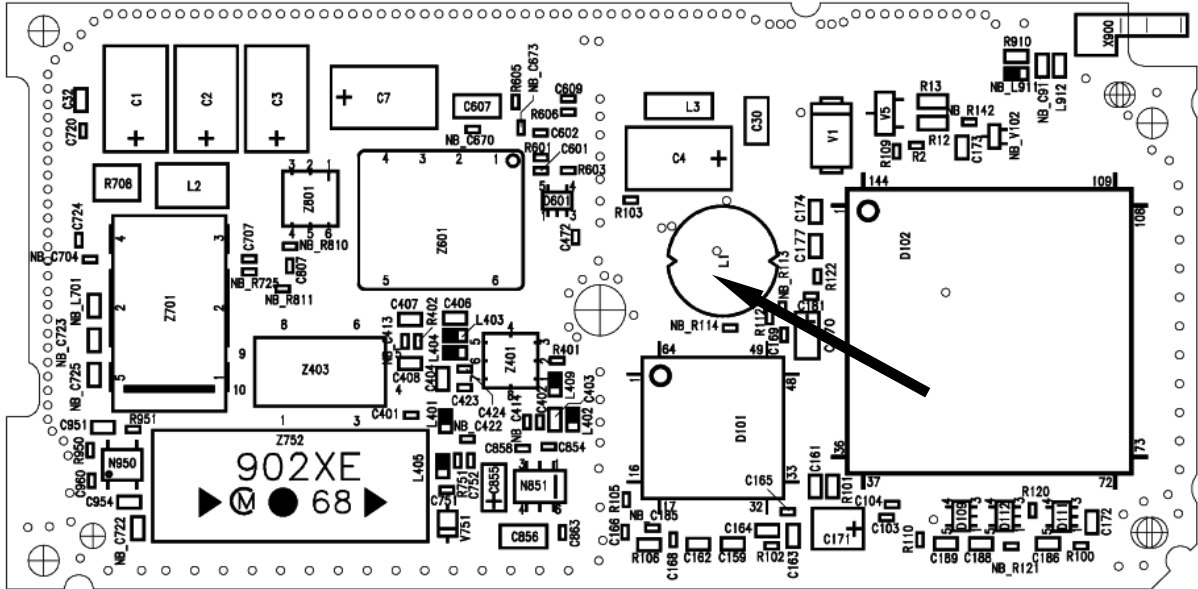
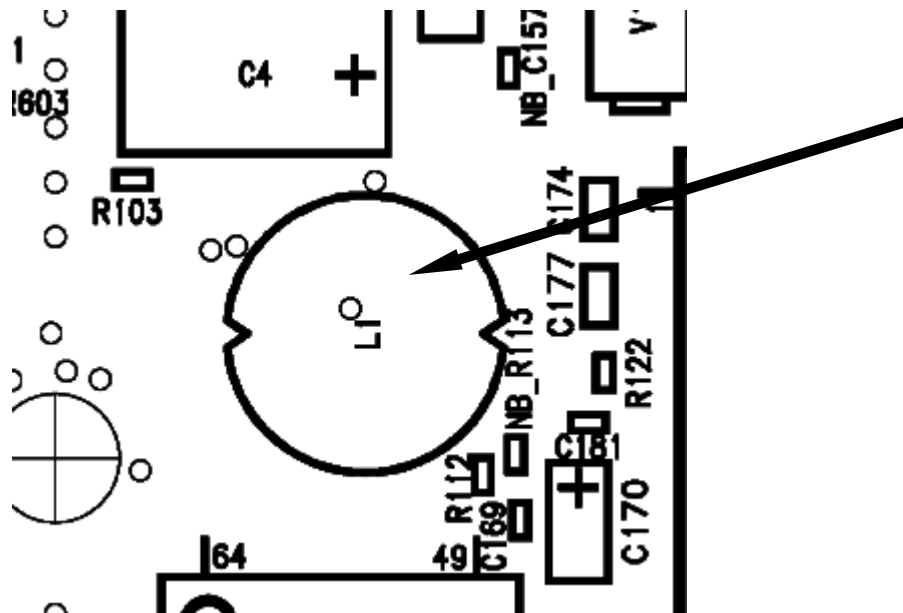
Figure 2: Coil (L1) Placement (Top View)

If the coil is mechanically damaged (broken) it produces heavy interference with the acoustical elements of the S10 resulting in a loud humming noise in the earpiece.

A broken coil can easily be diagnosed by trying to move it with two fingers. If it moves, the core is broken and the coil has to be replaced.

Use hot air to remove defective coil.  
Avoid excessive heat!  
Watch surrounding components!!

Resolder new coil afterwards

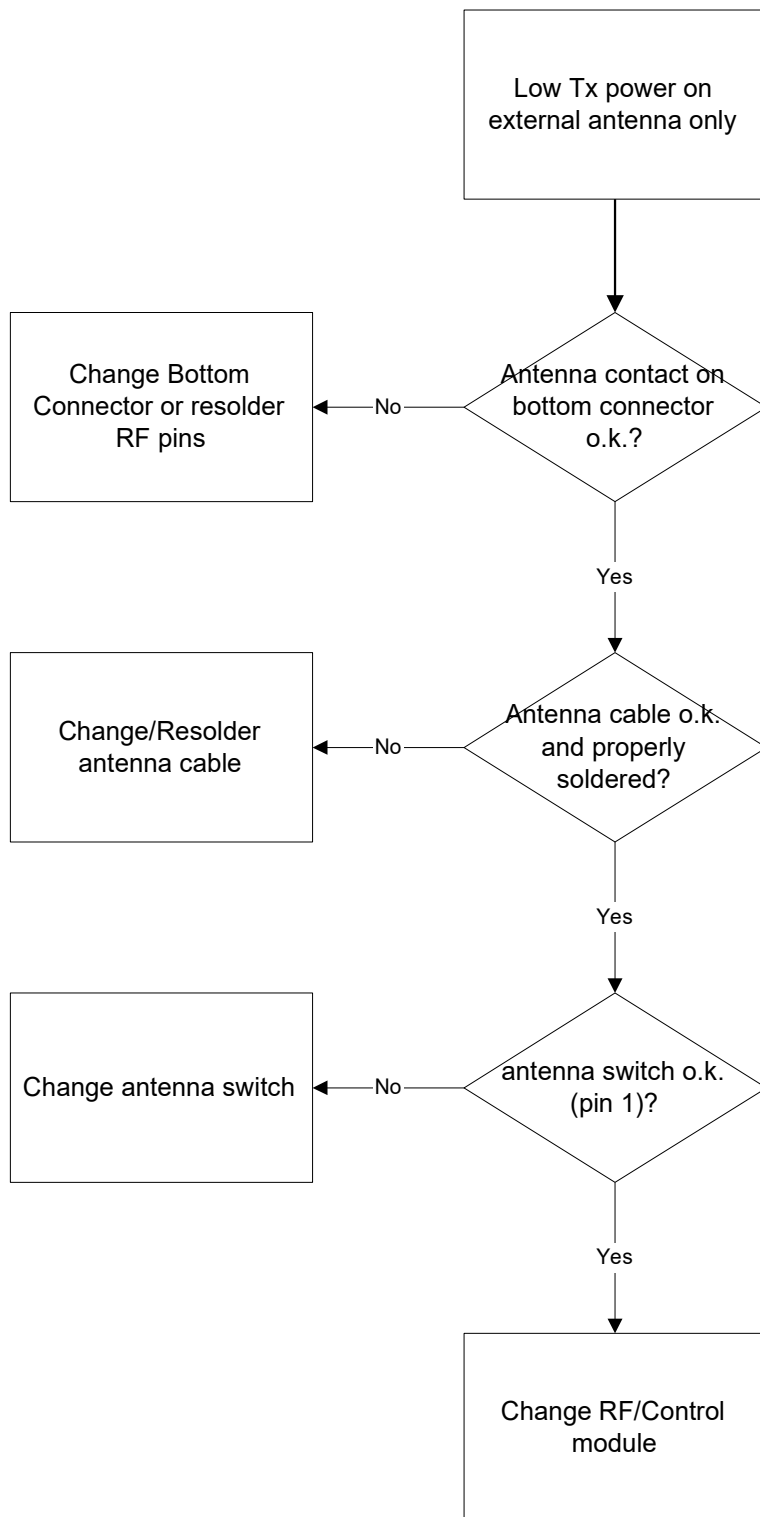
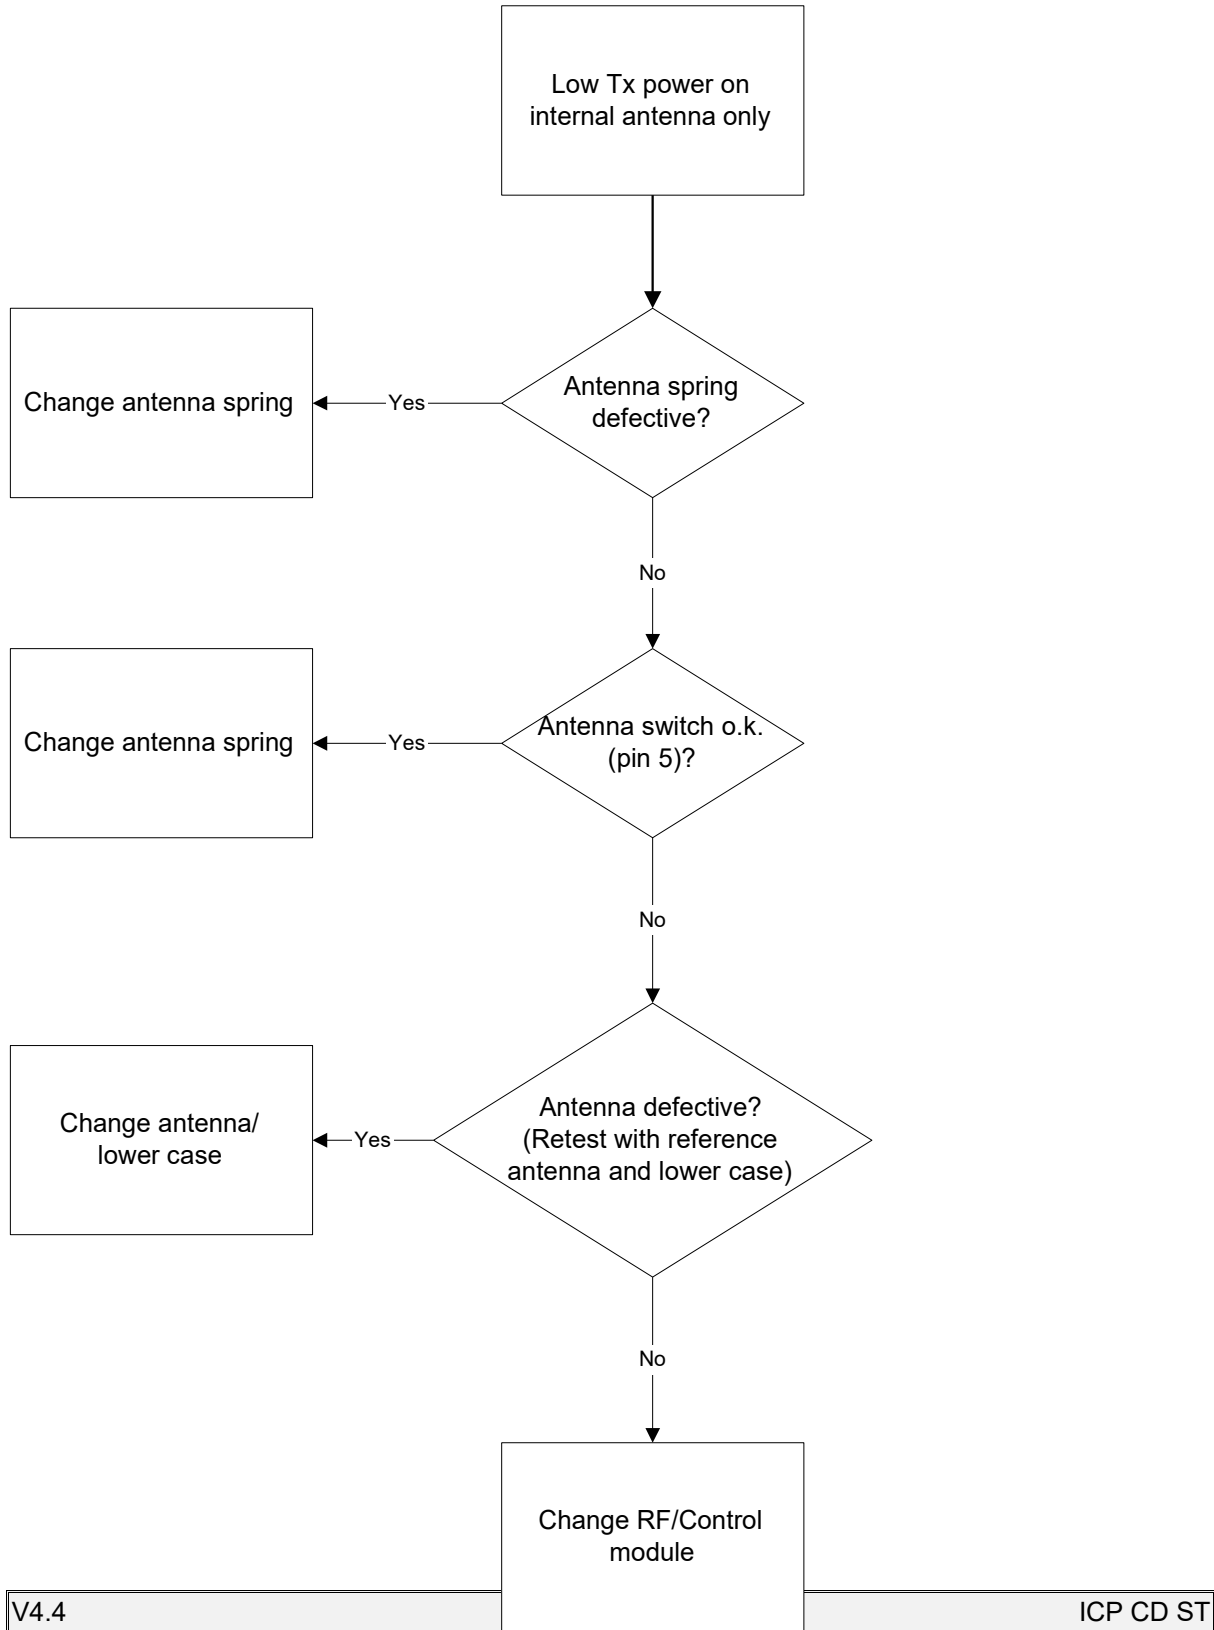
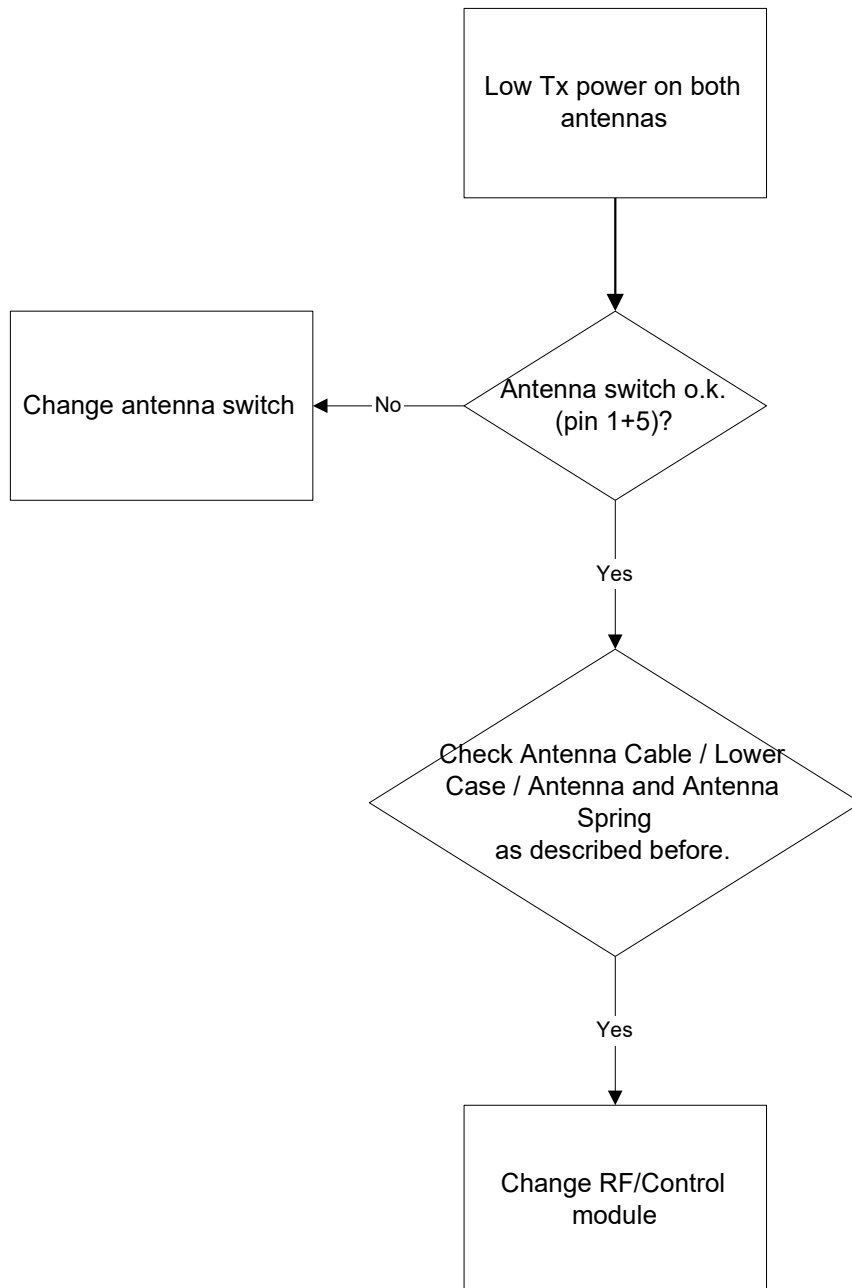
### 14.1 Tx power problems

If you experience a low output power on either antenna (internal/external) please follow the flowchart below.

**Remark:** If the Tx power problem is on both antennas, it is most likely a Power Amplifier problem which cannot be fixed locally.
