# S10 / S10 MMI

### Repair Documentation

#### Level 2.5

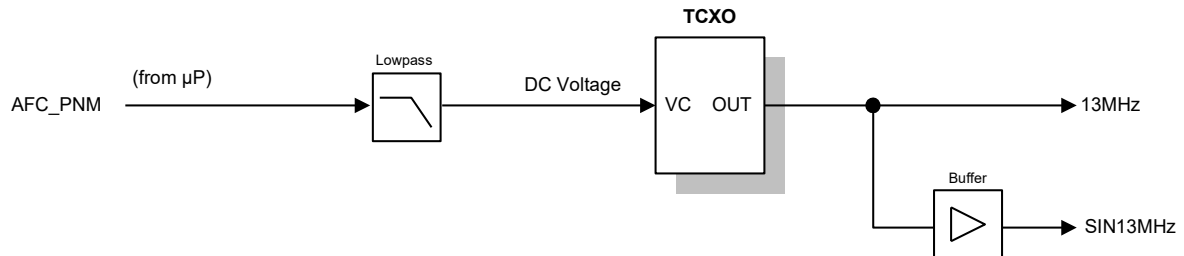
No location update possible

The TCXO (Temperature Compensated Crystal Oscillator) is responsible for generating the 13 MHz reference frequency of the handset. If it is defective, the handset cannot synchronize to the base station anymore.

All other frequencies are derived from this 13MHz reference, its stability is vital for the handset function.

If the frequency error is higher than 2kHz, the TCXO has to be replaced.

Use hot air blower to remove defective TCXO.

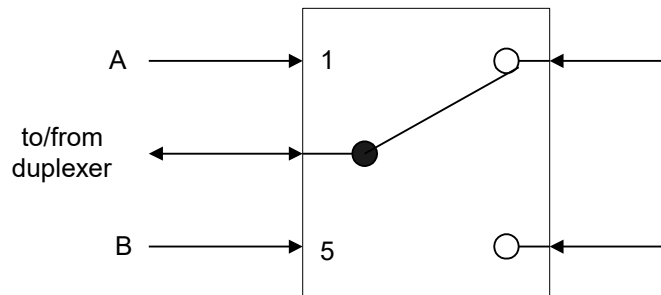
The antennaswitch is used to switch the Rx and Tx path between the internal an external antenna of the handset

The switched path is determined by two digital inputs A and B (pins 1 and 5).
